MISSISSIPPI
WATERSHED
MANAGEMENT
ORGANIZATION

Annual Monitoring Report 2016

MWMO Watershed Bulletin: 2017-1

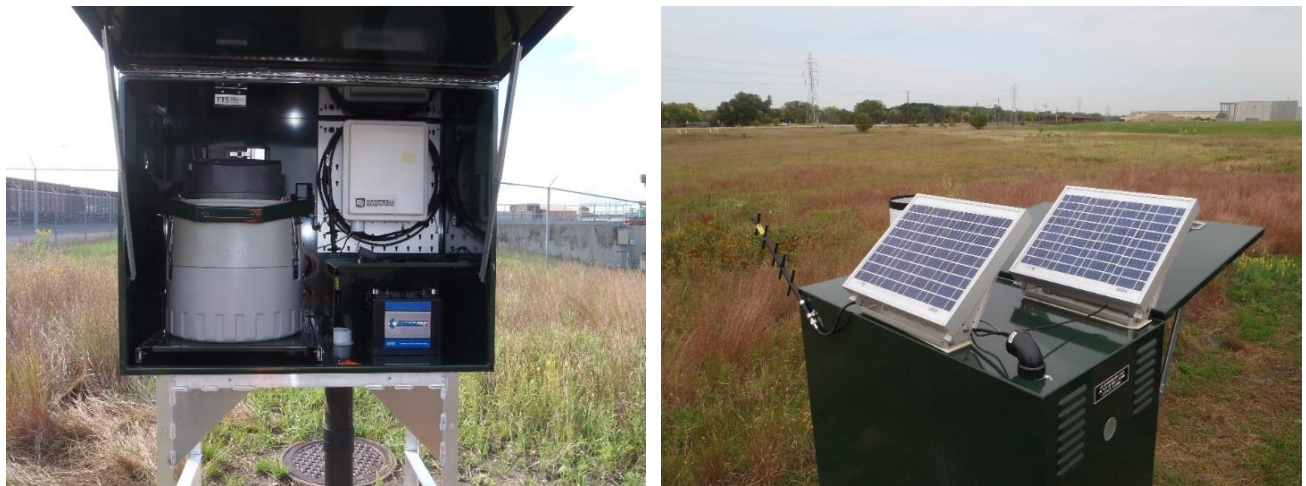
Figure 5. Example of a typical MWMO stormwater monitoring site cabinet setup, including automated sampling and continuous automated monitoring equipment.

Six MWMO stormwater monitoring sites are equipped with Isco 6712 automatic samplers (Teledyne Isco, Inc., Lincoln, NE). An Isco Area/Velocity sensor is installed in each of the six pipes and connected via cable to an Isco 750 Area/Velocity Flow Module which is attached to the automated sampler. The sensor and flow module provide water level and velocity data which are then used with pipe area dimensions to compute discharge from the stormwater pipe. A typical automated stormwater site set-up is shown in Figures 5 and 6.

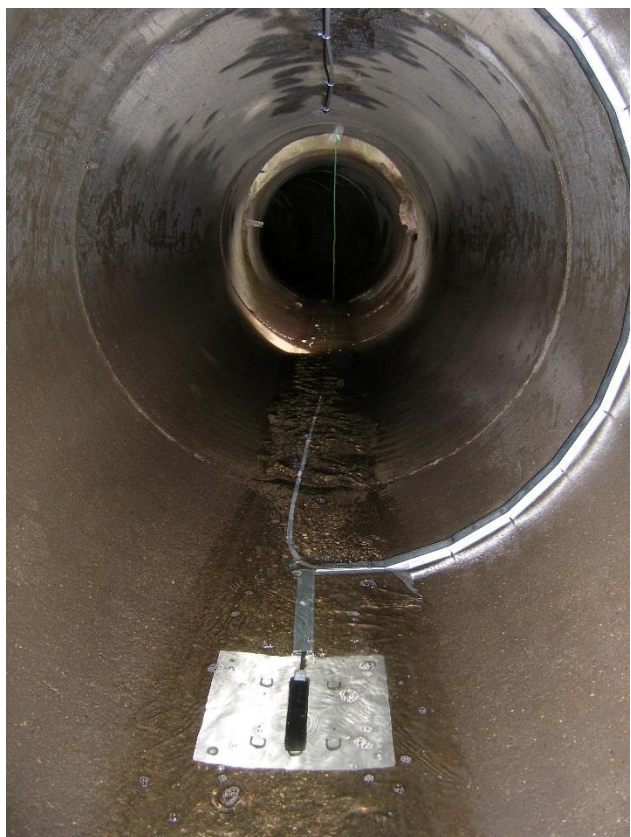
Figure 6. Typical area/velocity sensor (black rectangle) and cable and tubing configuration in a monitored stormwater tunnel.

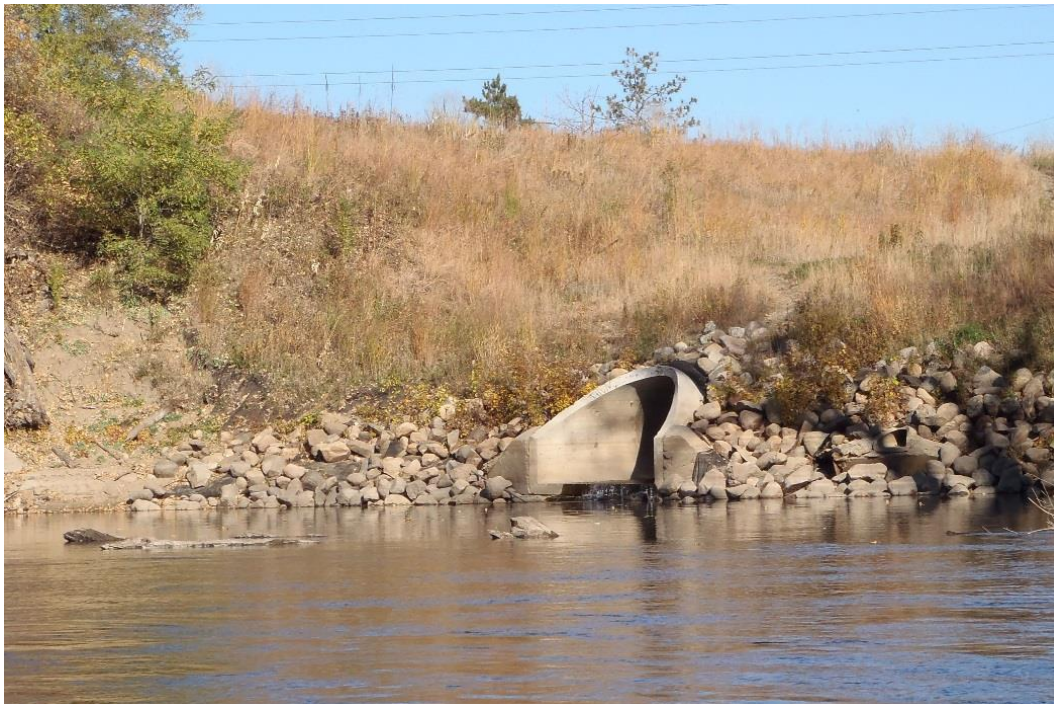
Figure 8. Site 11CHF outfall to the Mississippi River

This site is the northernmost outfall monitored by the MWMO. Installation of the site was completed in October 2014. The outfall is located on the east bank of the Mississippi River at RM 859, about 50 feet upstream from the northernmost edge of the Minneapolis Public Works Fridley Water Treatment Plant's property in the Anoka County Riverfront Regional Park. The outfall is a seven-foot diameter, round concrete pipe (Figure 8). The nearest intersection is 44th Avenue NE and East River Road. The monitoring equipment is located 1,880 feet up the tunnel from the outfall on BAE Systems Inc. property just west of the Burlington Northern Santa Fe rail yard and north of the rail yard's associated stormwater reservoir. This stormwater drainage system drains water from approximately 1,310 acres of parts of the cities of Columbia Heights, Hilltop, and Fridley (Figure 9). The pipeshed includes mainly industrial and residential land uses. The stormwater drainage system has continuous baseflow.

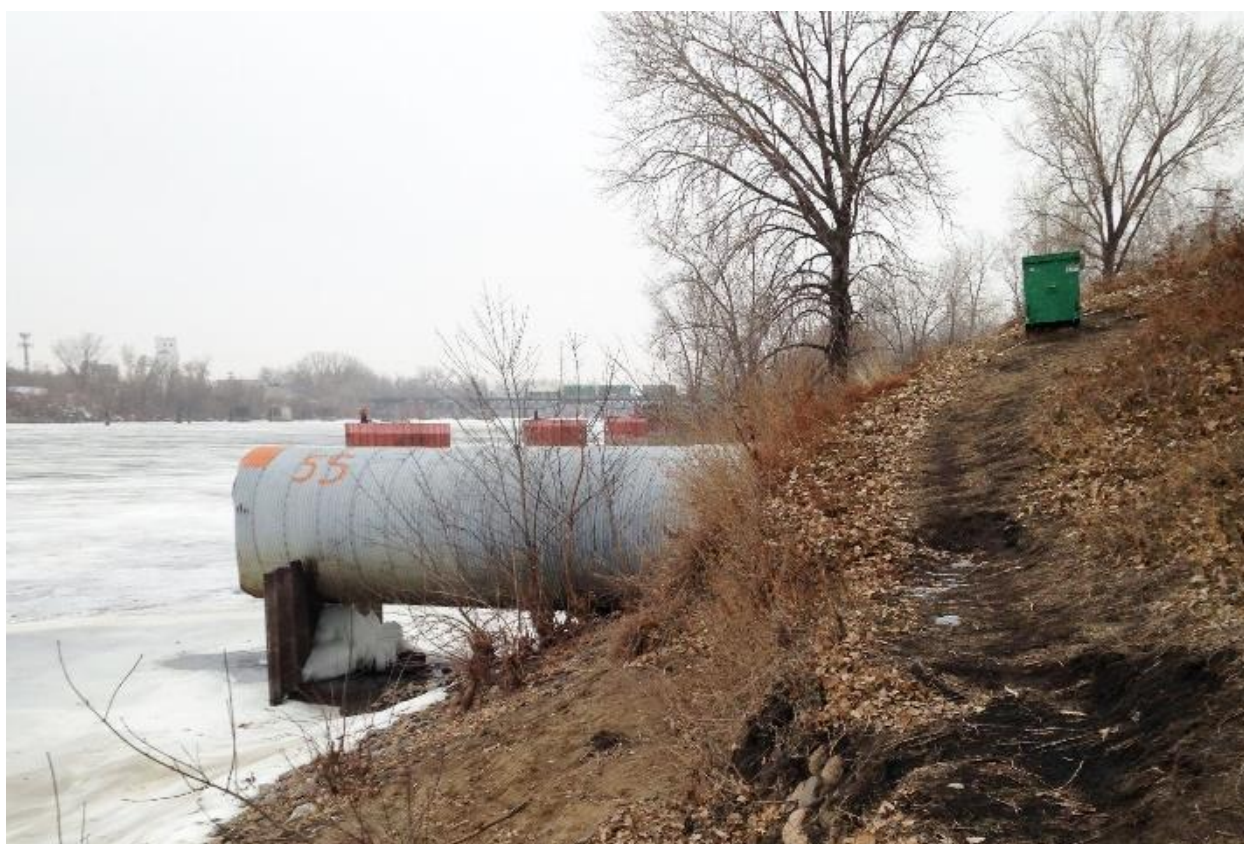
Figure 11. Outfall to the Mississippi River for the 1NE pipeshed. Monitoring cabinet can be seen in the upper right corner (green box).

Stormwater monitoring equipment was initially installed at the 1NE outfall site in 2006. The outfall is located on the east bank of the Mississippi River on the Xcel Riverside Power Plant property at RM 857.2 and is an eight-foot diameter, corrugated iron pipe (Figure 11). The stormwater drainage system drains water from approximately 2,240 acres of the Northeast Minneapolis neighborhood as well as portions of Columbia Heights and Fridley (Figure 12). The pipeshed includes mainly residential and industrial land uses. The stormwater drainage system has continuous baseflow.

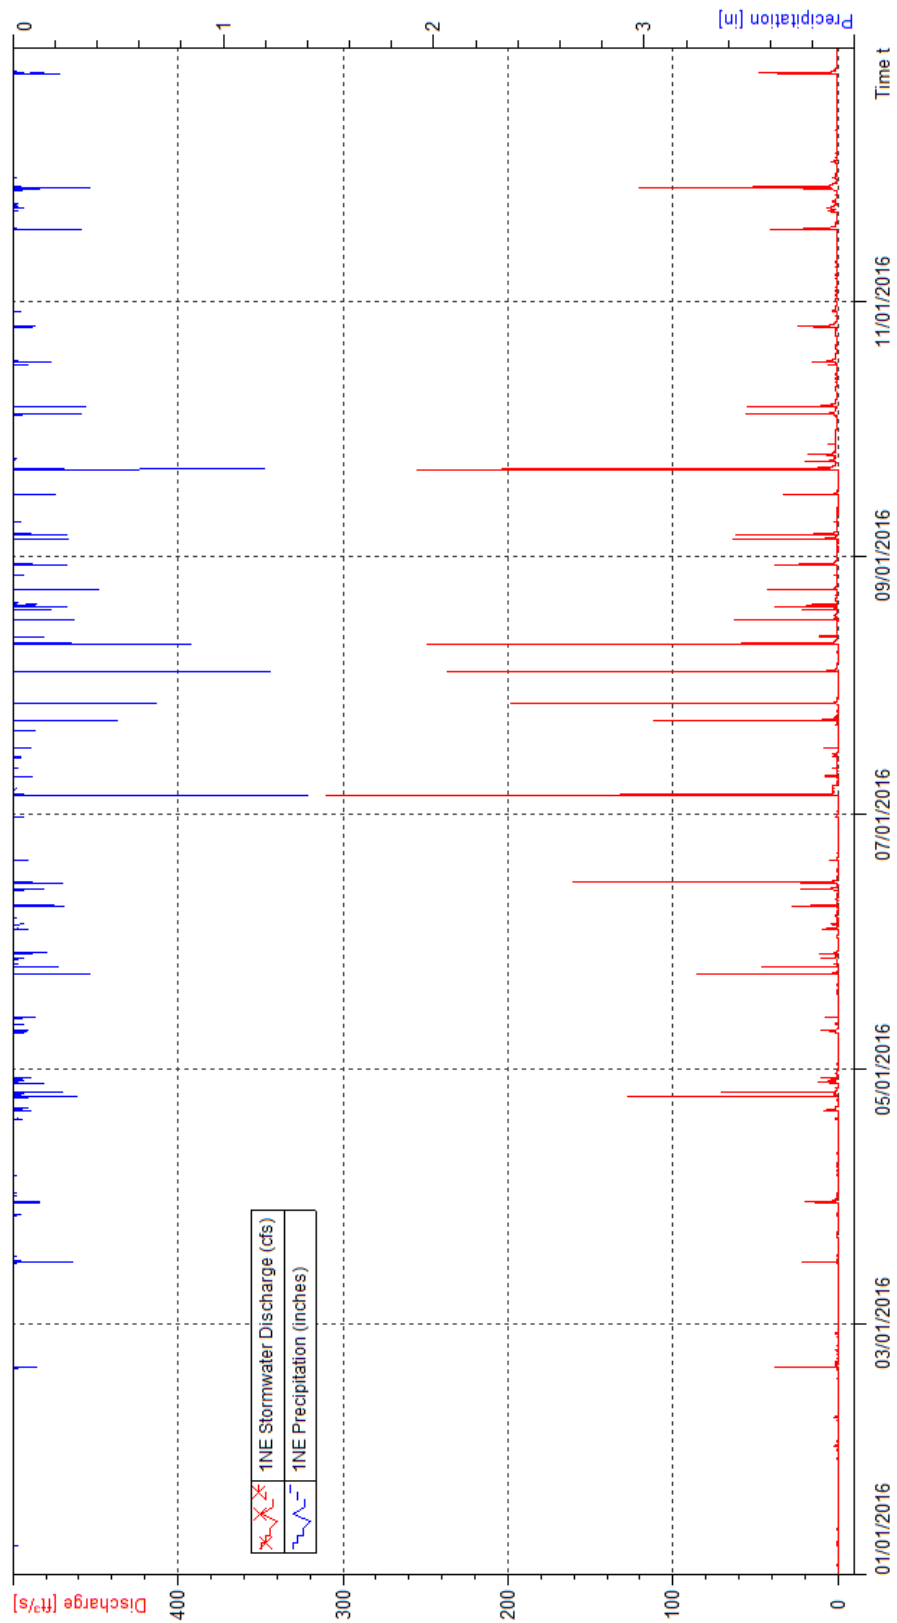
Figure 13. Stormwater discharge and hourly precipitation totals at the 1NE monitoring site in 2016.

Stormwater discharge and precipitation data collected with automated equipment are presented in Figure 13. Cold weather caused the automated sampler to shut off occasionally, resulting in brief gaps in level and discharge data. During periods of time when the baseflow water level was very low (typically winter and fall) the sensor could not measure stormwater discharge. Those periods are represented as gaps in the discharge data.

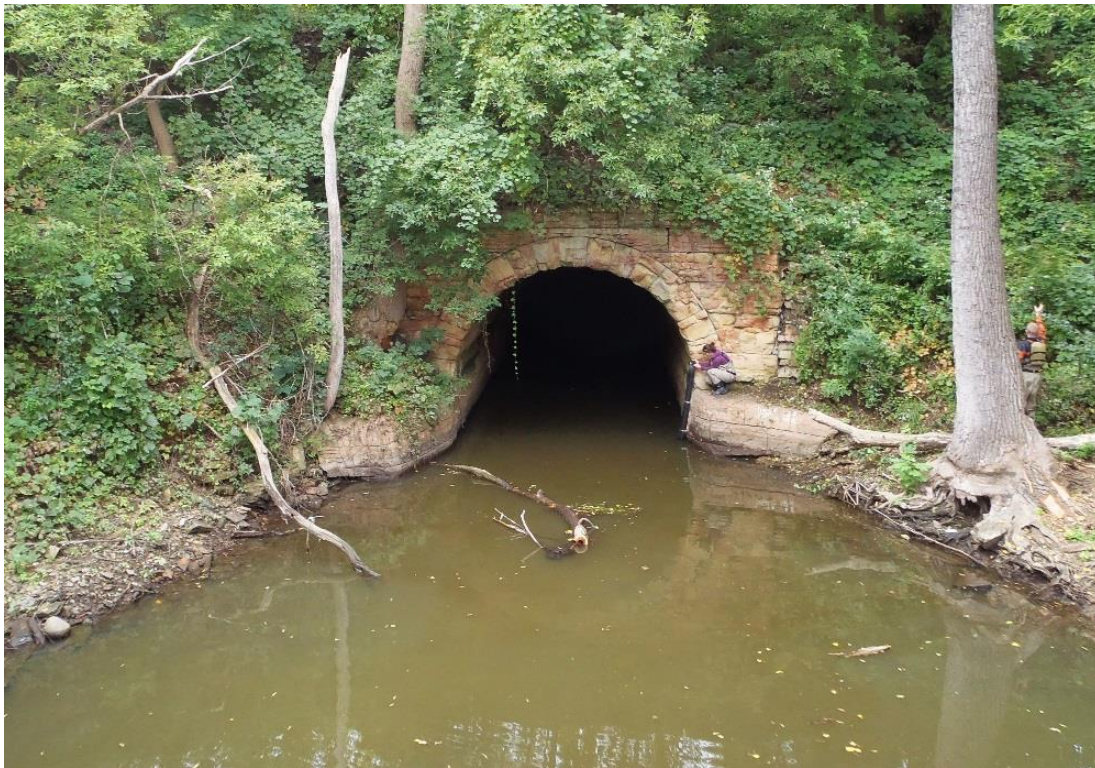
Figure 14. The 2NNBC outfall to the original Bassett's Creek channel before it enters the Mississippi River.

The 2NNBC outfall drains water from 1,067 acres of the Near North Minneapolis neighborhood and Bassett's Creek overflow. It enters the river in a park in the North Loop neighborhood of Minneapolis on the west bank of the Mississippi River at RM 854.8. Land use in the pipeshed is primarily residential and commercial. The semi-elliptical outfall is approximately 11 feet high and 15 feet wide (Figure 14). Bassett's Creek was buried and routed through this tunnel in 1890. In 1992, the creek was rerouted through a new tunnel that enters the Mississippi River below the surface water level, just downstream from Upper Saint Anthony Falls. Water from Bassett's Creek only flows through the original outfall during overflow periods. The 2NNBC pipeshed is shown in Figure 15.

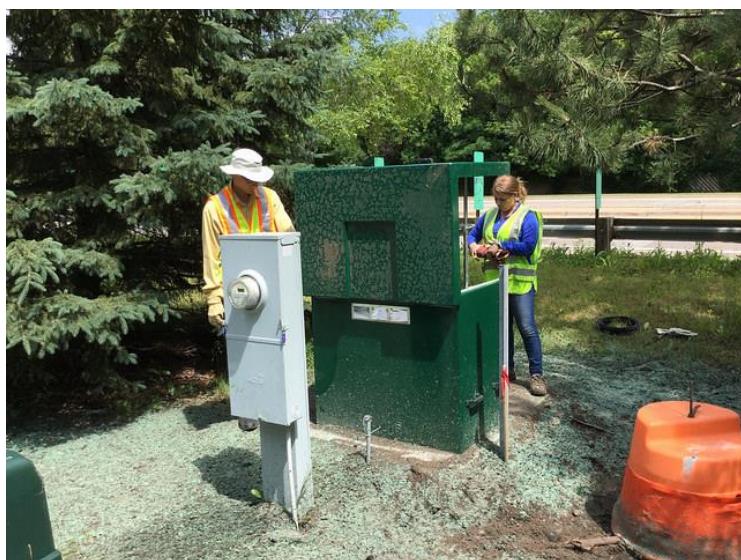
Figure 16. Monitoring cabinet and access manhole at the 10SA stormwater site.

The 10SA monitoring site was established in 2007. 10SA differs from the other MWMO stormwater monitoring sites as it is located at the jurisdictional boundary between St. Anthony Village and Minneapolis, rather than at an outfall to the Mississippi River. The MWMO chose to monitor this location to investigate the quantity and quality of stormwater from the southern portion of St. Anthony Village (602 acres) as it enters Minneapolis. The concrete stormwater pipe is four and a half feet in diameter and is accessed at a manhole within an open space in a residential neighborhood (Figure 16). The tunnel eventually drains into the Mississippi River several miles away on the east bank at RM 853.2. The monitored pipeshed is shown in Figure 17. Land uses are mainly residential, commercial, and industrial. There is generally continuous baseflow in this stormwater drainage system although the amount is negligible in winter. In 2016, the original equipment cabinet was replaced with a new one in conjunction with the installation of monitoring cabinets just upstream of the 10SA site at the new St. Anthony Regional Stormwater Treatment and Research System (see BMP monitoring section).

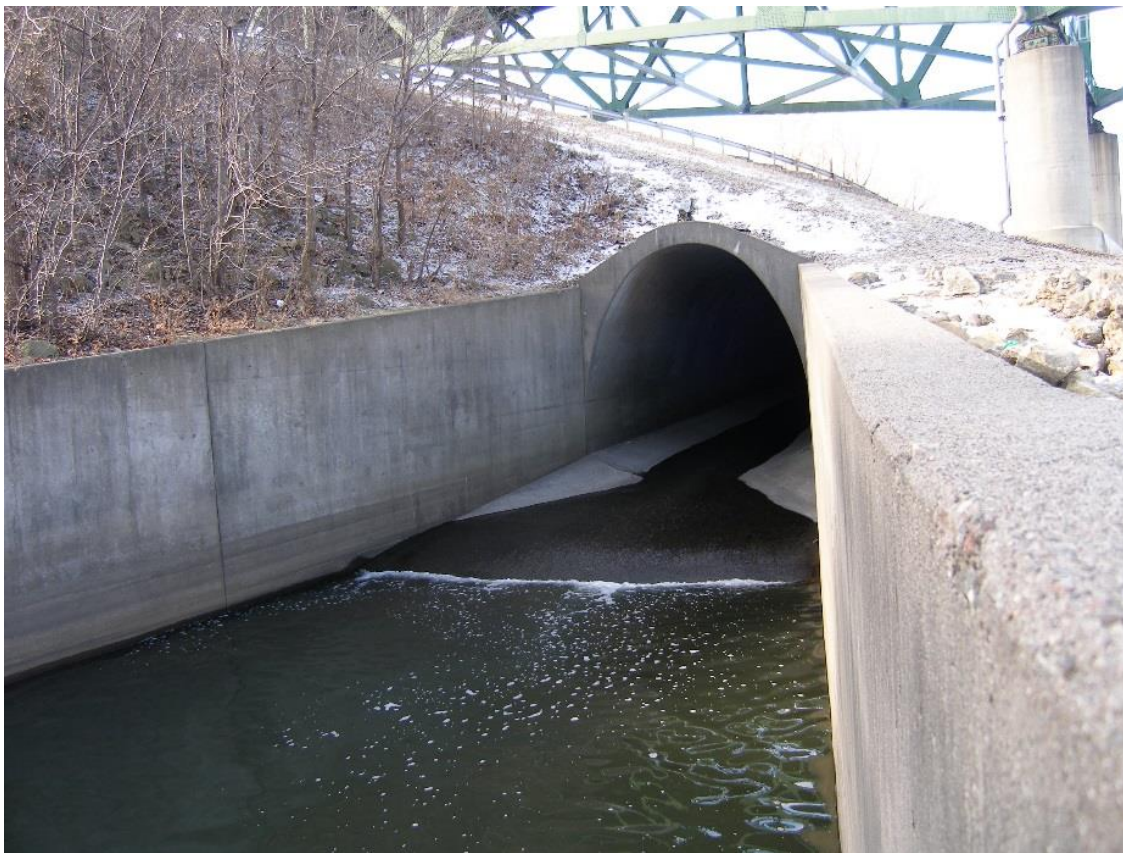
Figure 19. 4PP outfall to the Mississippi River.

Established in 2008, this stormwater outfall monitoring site is located below Lower Saint Anthony Falls Lock and Dam on the west bank of the Mississippi River at RM 853.2. The semi-elliptical tunnel is 14 feet high and 14 feet wide (Figure 19). The system drains stormwater from approximately 2,780 acres of the Phillips and Powderhorn Neighborhoods and the southern portion of the Central neighborhood in Minneapolis, as well as water from the I-35W interstate highway (Figure 20). Land use is primarily residential, commercial, and heavy industry. There is continuous baseflow in this stormwater drainage system.

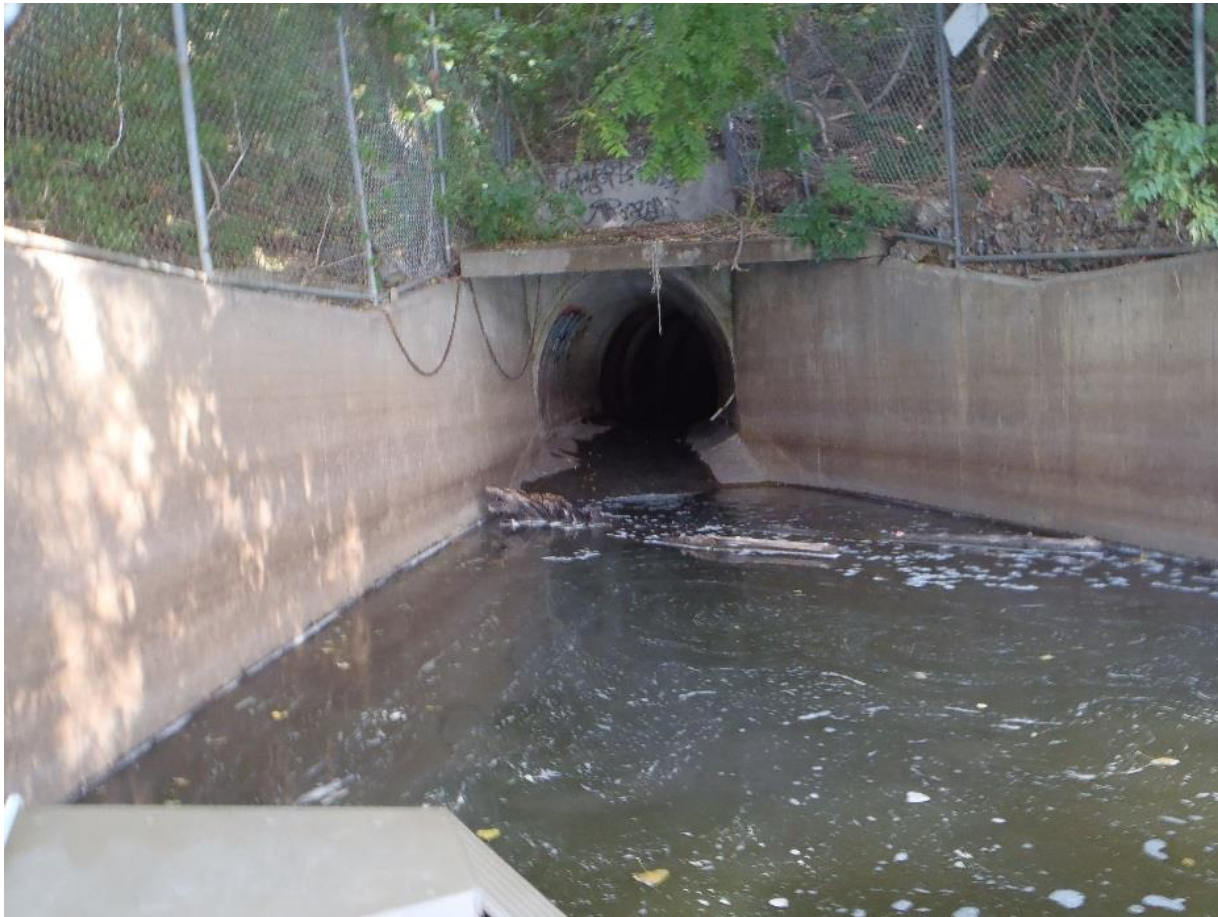
Figure 21. 6UMN outfall to the Mississippi River.

The 6UMN outfall site is located on the east bank of the Mississippi River at RM 853.0, downstream from Saint Anthony Falls, behind the University of Minnesota Main Energy Plant. The monitoring site was established in 2006. This semi-elliptical tunnel is eight feet high and eight feet wide with a rounded top and slightly U-shaped base (Figure 21). The outfall drains water from approximately 765 acres of the City of Minneapolis and the University of Minnesota, Minneapolis Campus (Figure 22). Land use is primarily residential and commercial. There is continuous baseflow in this stormwater drainage system.

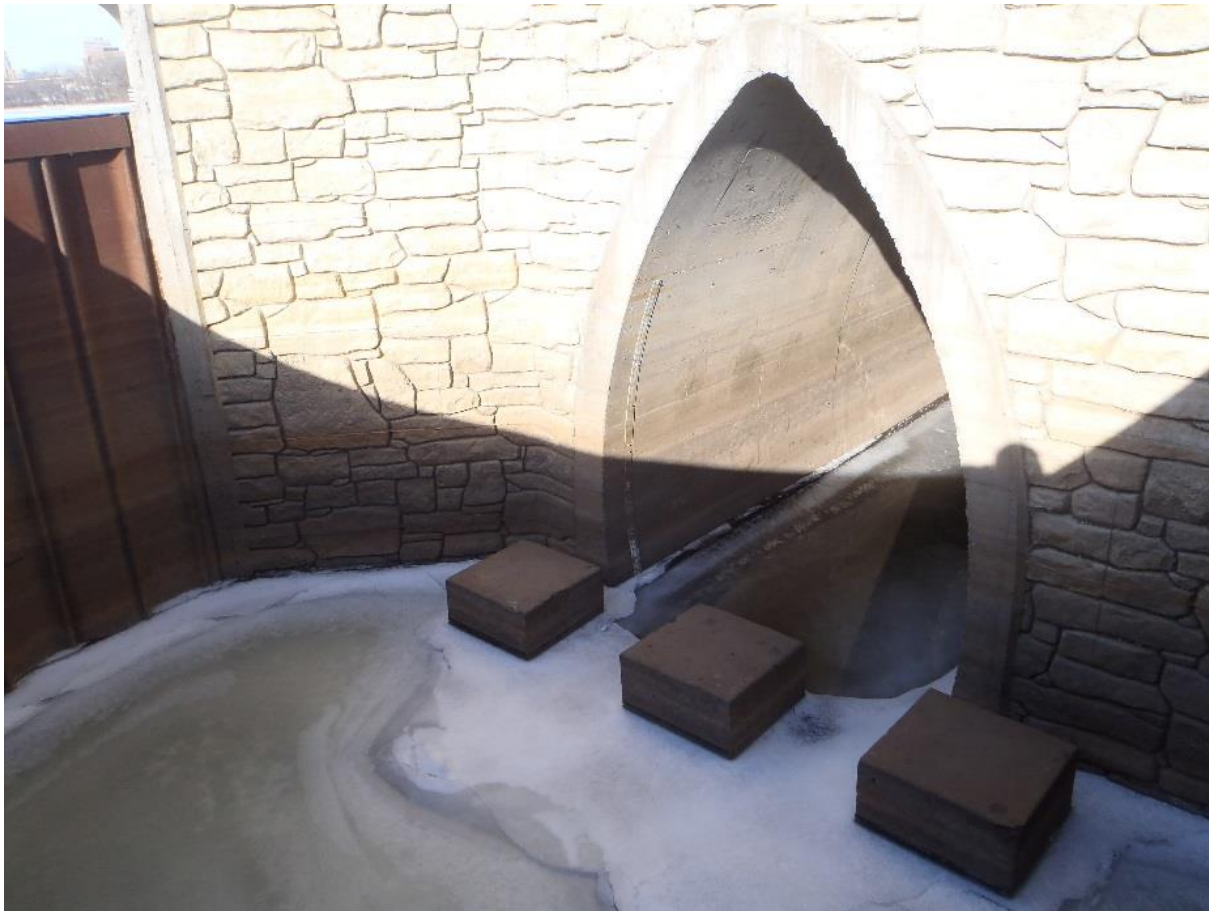
Figure 24. 7LSTU outfall to the Mississippi River.

7LSTU is the farthest downstream stormwater outfall monitored by the MWMO. The monitoring site was established in 2008 and is located on the east bank of the Mississippi River at RM 851.6, between the I-94 Bridge and Franklin Avenue Bridge. The cathedral-shaped tunnel is 10.37 feet high and 6.67 feet wide at its base (Figure 24). At the mouth of the outfall, five square, concrete pillars baffle (slow) water flow, and an iron stilling basin captures floatable debris. The outfall drains water from approximately 600 acres of the City of Minneapolis and the University of Minnesota's Minneapolis Campus (Figure 25). Land uses within the pipeshed are a mix of residential, commercial and industrial.

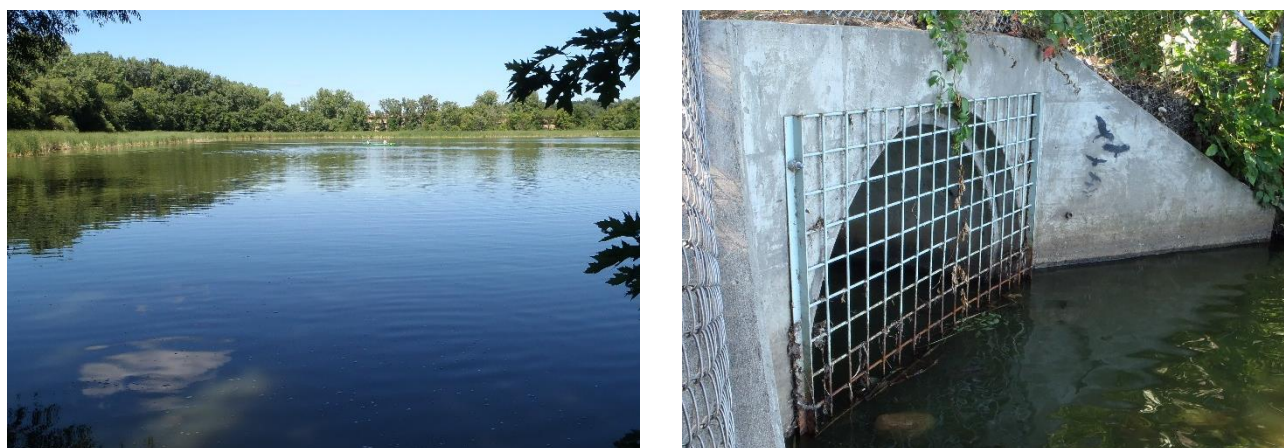
Figure 27. Image of Sullivan Lake (left) from 2013. Image of Sullivan Lake's outlet (right).

Sullivan Lake, also known as Sandy Lake, is located in south central Anoka County. The lake has a surface area of approximately 16.8 acres and a maximum depth of 9 feet (2.7 m). A walking trail circumscribes the lake with a mix of residential, commercial, and retail properties adjacent to the trail. The walking trail around the lake is used extensively, but due to lack of open water access, the lake is seldom used for swimming, fishing, or boating. Sullivan Lake's watershed is highly urbanized, and the lake essentially serves as a flow-through stormwater pond. The lake is connected directly to the curb and gutter stormwater system which heavily influence its water quality (Figure 27). Water exiting Sullivan Lake is discharged to the Mississippi River via stormwater conveyances. A staff gauge is located on the west side of the lake near the outflow. The gauge is surveyed each year by ACD and the Minnesota DNR using datum NGVD 29 in feet. The Minnesota DNR lake ID for Sullivan (Sandy) Lake is 02008000.

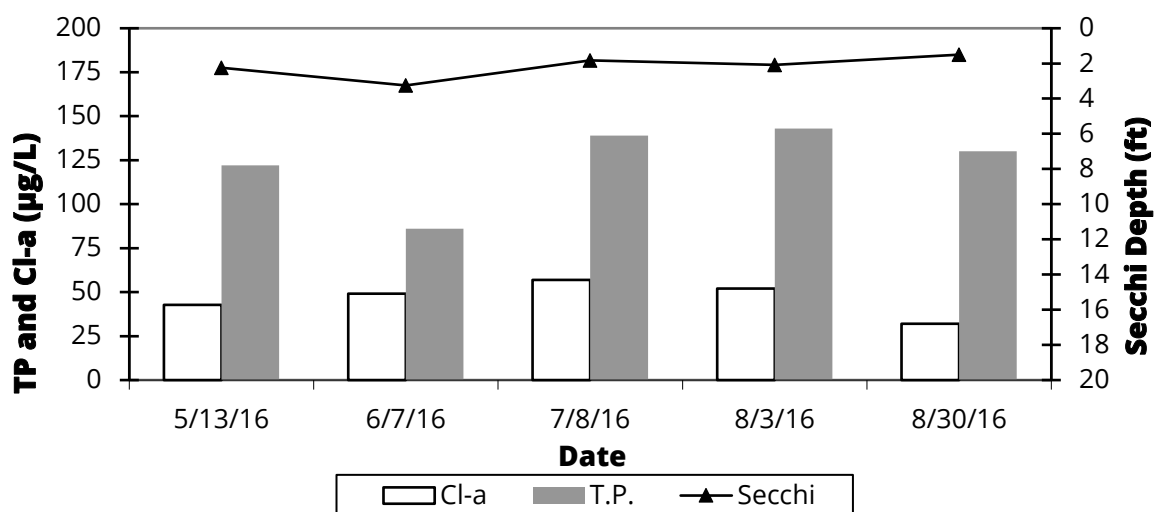
Figure 28. Sullivan Lake chlorophyll-a (µ/L), total phosphorus (µg/L), and Secchi depth (ft) during 2016.

The ACD monitored water quality in Sullivan Lake monthly from May to August 2016. ACD monitored the following parameters: total phosphorus, chlorophyll-a, chloride, Secchi depth, D.O., turbidity, temperature, conductivity, pH, and salinity. Figure 28 illustrates 2016 total phosphorus, chlorophyll-a, and transparency data.

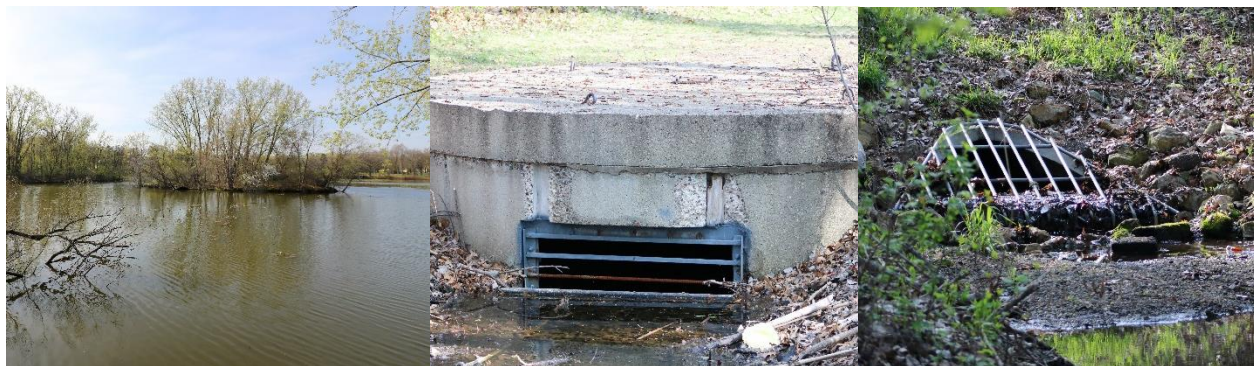
Figure 31. Image of Highland Lake from 2016 (left), the lake's outlet (center) and one of its inlets (right).

Highland Lake is a very shallow lake surrounded by a wooded park and residential neighborhood in south central Anoka County. The lake has a surface area of approximately 14 acres with two small islands in the northeastern corner. Similar to Sullivan Lake, Highland Lake's watershed is highly developed, and the lake essentially serves as a flow-through stormwater pond. It is connected directly to the curb and gutter stormwater system (Figure 31). Water exiting this lake is discharged to the Mississippi River via stormwater conveyances. Highland Lake's water level gauge is located on the north side of the lake, near the intersection of Argonne Drive and Innsbruck Parkway.

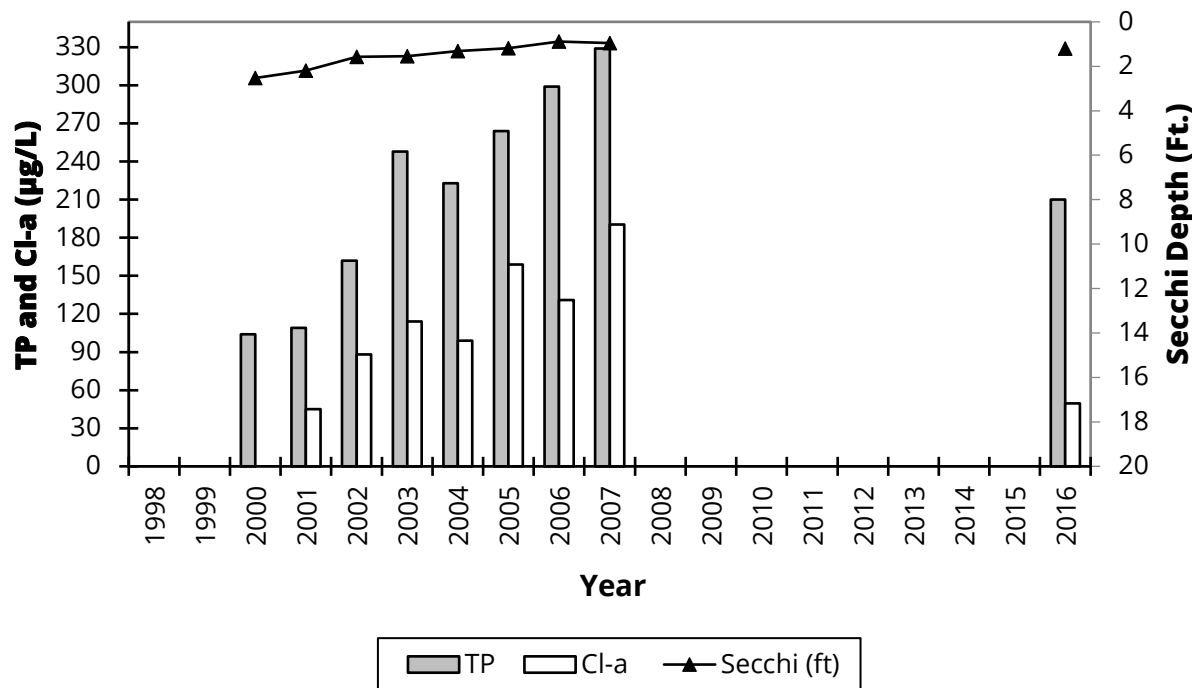
Figure 34. Highland Lake historic summertime means of total phosphorus ($\mu\text{g/L}$), chlorophyll-a ($\mu\text{g/L}$), and Secchi depth (ft).

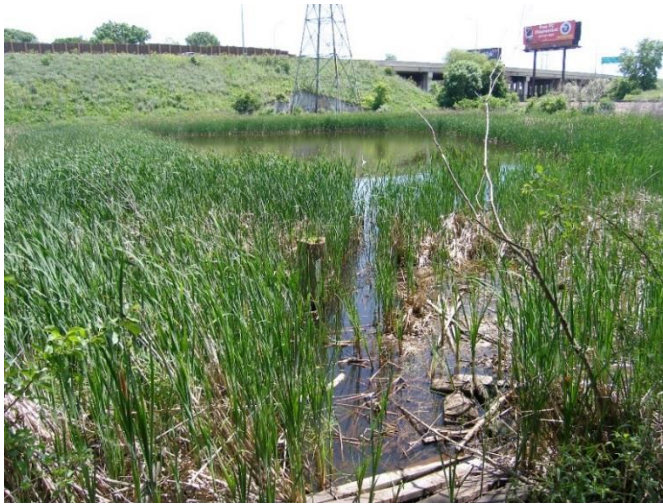
Figure 36. Kasota Pond North.

KPN is the northernmost pond. It is located west of Highway 280 and south of the intersection of North Hunting Valley Road and West Doswell Avenue. The area surrounding the pond is heavily vegetated with non-native species such as buckthorn and burdock. KPN is dense with cattails and other aquatic plants during the summer months (Figure 36). The bottom of the pond is composed of organic matter, silt and clay.

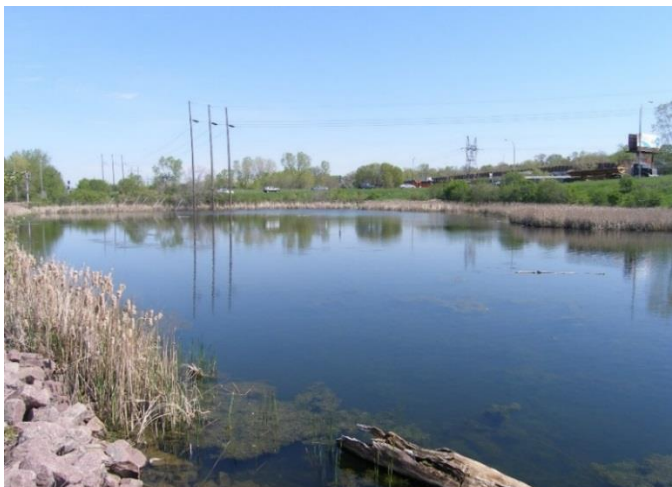
Figure 37. Kasota Pond East.

KPE, also known as Mallard Marsh, is the largest of the ponds. It is located southwest of the intersection of Highway 280 and Kasota Avenue. A grassy buffer area surrounds most of the pond, except for the west side of the pond, where railroad tracks are separated from the waterfront by

approximately six feet of riprap. Turtles, geese and ducks are frequently observed in KPE. This wetland is dense with cattails and aquatic plants during the summer months (Figure 37). The bottom of the pond is composed of organic matter, silt, and clay.

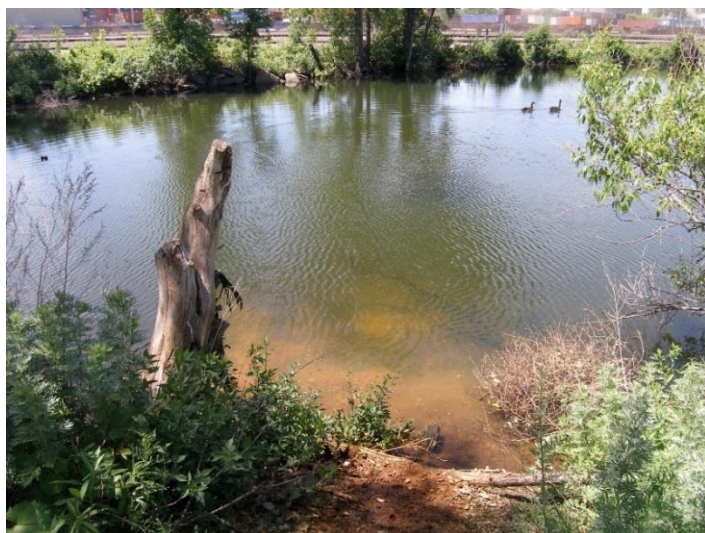
Figure 38. Kasota Pond West.

KPW, located just west of KPE, receives runoff from a parking lot and nearby rail yard. Dense algal blooms are observed in KPW during the summer months, while other types of aquatic vegetation are seldom present in this pond (Figure 38). The pond has a sandy bottom.

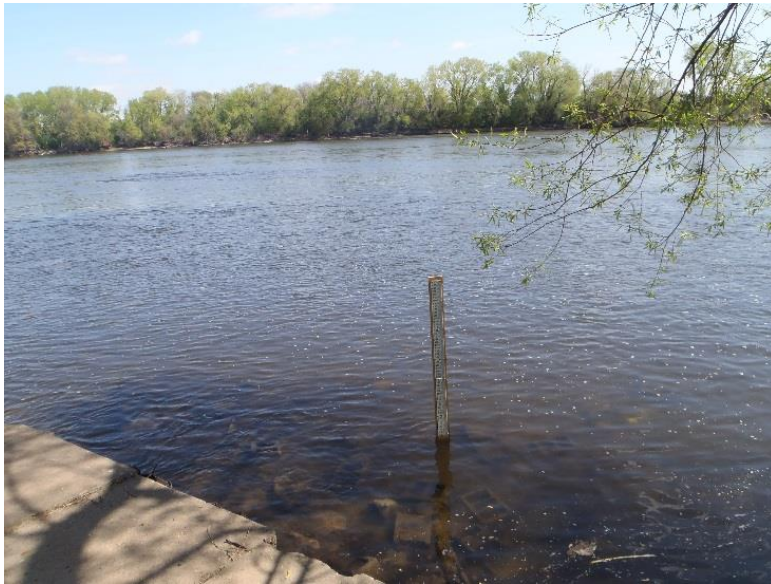
Figure 41. MWMO bacteria sampling site MR859.1W (Camden) with staff gauge.

The Camden site is the northernmost bacteria monitoring site in the MWMO's watershed. It is located in the North Mississippi Regional Park in Minneapolis. The terrain surrounding the site is mostly deciduous forest with a grassland transition zone by the road. There is a concrete levy wall and boulders at the sampling site and an outfall just upstream. The river is shallow (three-five foot depth), rocky, and swift with sand and gravel bars up and downstream (Figure 41). Water levels fluctuate at this site more than at any other in the watershed. Waterfowl are commonly seen in the river and on shore. Rabbits, bald eagles, a Blanding's Turtle and a beaver have also been observed.

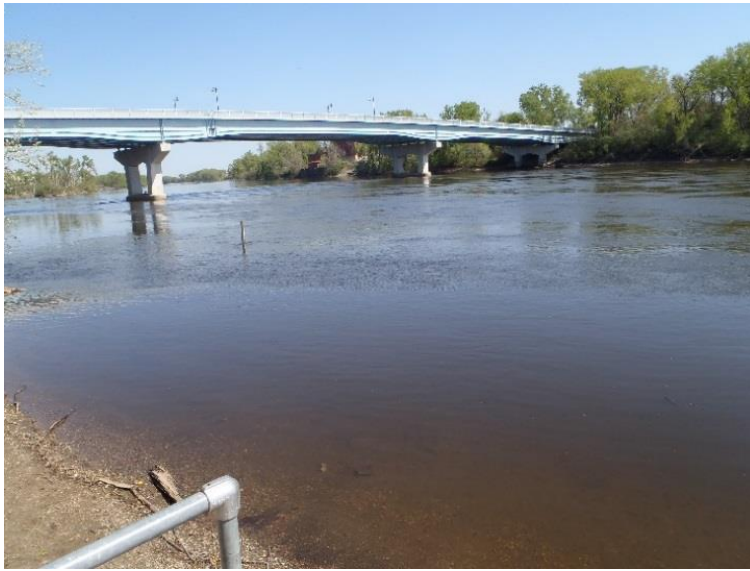
Figure 42. MWMO bacteria sampling site MR 857.6W (MPRB Boat Launch at North Mississippi Regional Park).

This site is located adjacent to MPRB land. A paved parking lot leads to the river and boat launch. Flat and forested terrain surround the parking lot and boat launch area with some grassy areas and recreational trails leading up and downstream. The river bottom near shore is silty mud and gravel with scattered large stones. The river is deeper here than at MR859.1W, and a swift current can be observed after rainfall. The monitoring site is upstream of the dock foundation and downstream of the mouth of Shingle Creek (Figure 42).

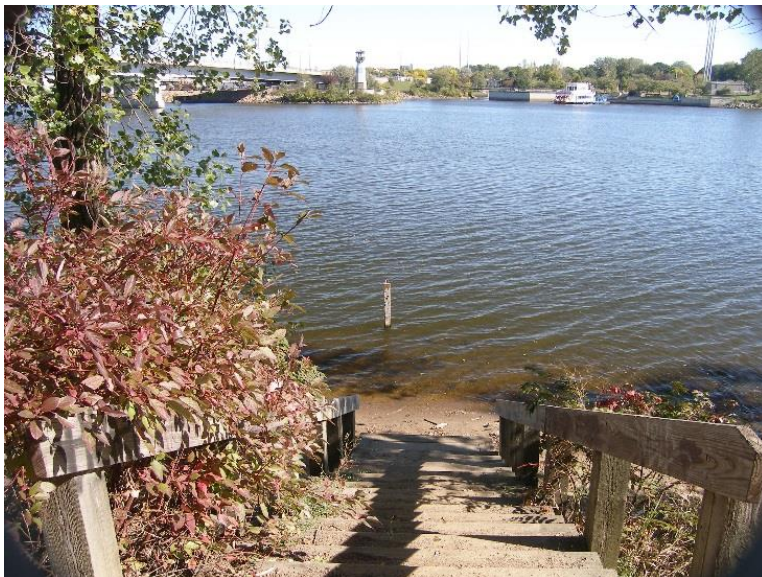
Figure 43. MWMO bacteria sampling site MR 854.9W (North Loop) with staff gauge.

The North Loop site is located downstream from the Plymouth Avenue Bridge. It is adjacent to a shaded park area with picnic tables, trails, grass and trees. The riverbank is steep and covered in brush. The shore and shallows at the sampling site are composed of loose rocks and sand. The monitoring site is at the base of a stairway that leads to the river (Figure 43).

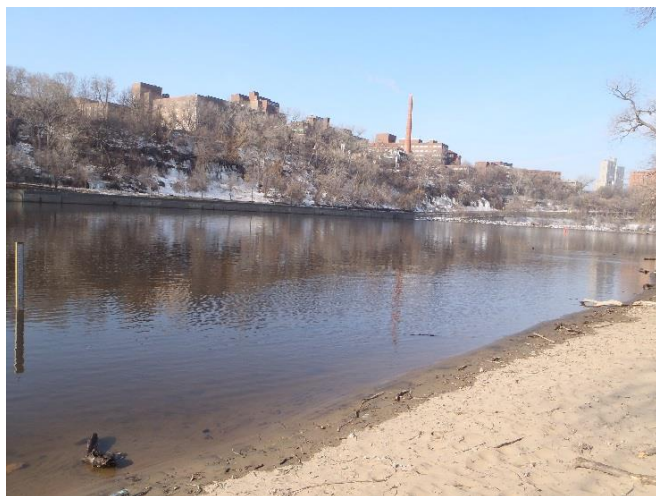
Figure 45. MWMO bacteria sampling site MR852.2E (University of Minnesota Boat Launch) with staff gauge.

The University of Minnesota Boat Launch site is the first river site downstream from Lower Saint Anthony Falls. It is located in the Mississippi River Gorge, behind Coffman Union on the University of Minnesota East Bank Campus. The sampling site is 100 feet upstream of the boat launch and floating dock that is used by the rowing teams. The surrounding terrain consists of deciduous forest along the river and a large grassy area behind the trees. The gently sloping bank leads to a sandy shore that continues into the river (Figure 45). The site is a regular entrance point to the river for geese that graze on the grass in the open area. Goose droppings are common here.

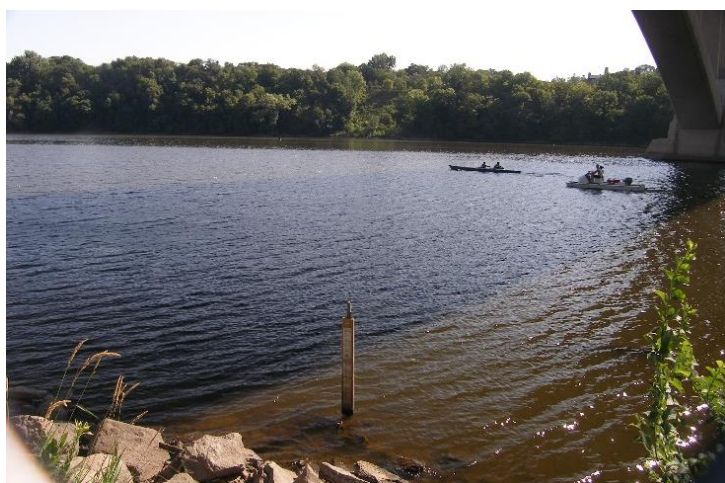
Figure 46. MWMO bacteria sampling site MR849.9W (Lake Street Bridge) with staff gauge.

This site is located beneath the Lake Street Bridge, which crosses over the Mississippi River. The elevation drops more than 70 feet from the street to the river. A small stormwater outfall and the Minneapolis Rowing Club boat facility are located just upstream of the site. Tall grass runs along the river and trees on the sides of the gorge can be seen (Figure 46). A steep, three foot riverbank leads to a rocky shore and a sandy river bottom with limestone boulders and gravel (riprap).

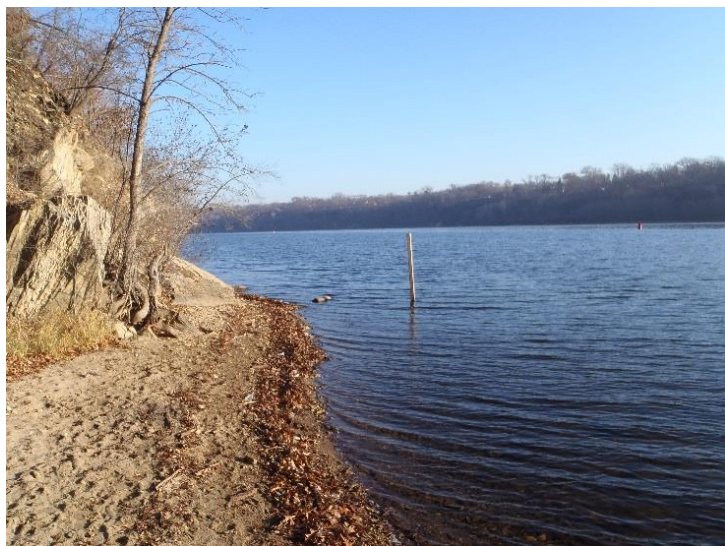
Figure 47. MWMO bacteria sampling site MR848.1W (4300 West River Parkway) with staff gauge.

This site is the farthest downstream in MWMO's watershed, located less than one mile upstream from Lock & Dam No. 1. The site is surrounded by hardwood forest and is just upstream from a stormwater outfall. The shore and river bottom are made up of sand and large, flat limestone rocks (Figure 47).

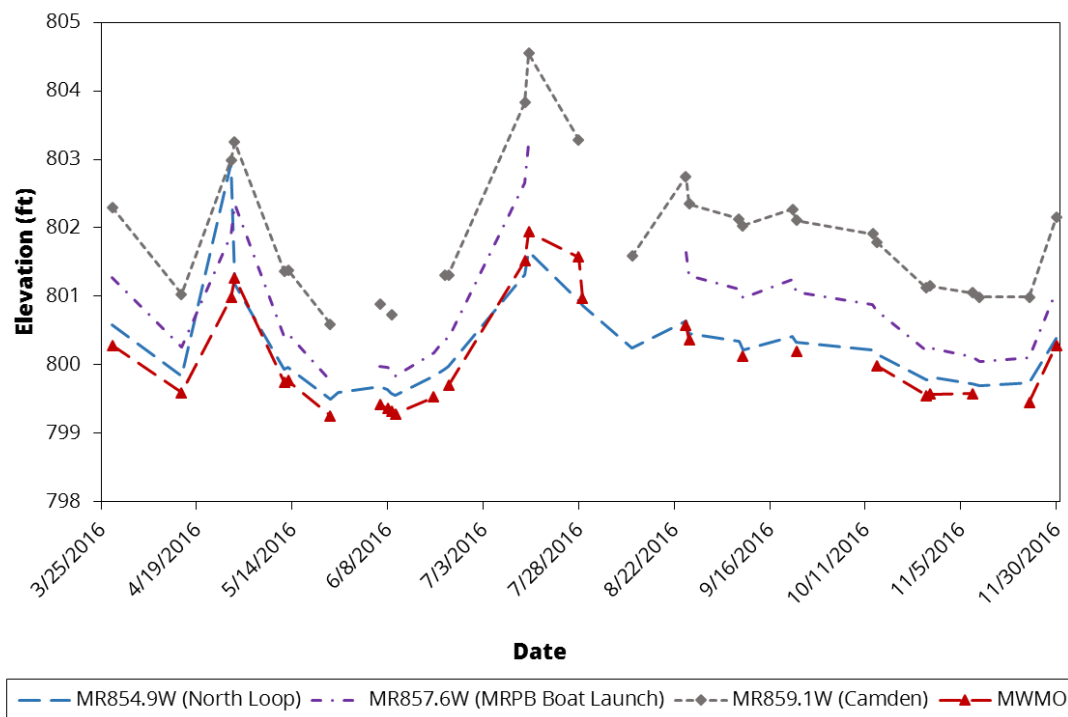
Figure 48. Mississippi River water elevations at four monitoring sites upstream of Saint Anthony Falls, including one near MWMO's office building at RM856.6.

Staff gauges were installed on March 28, 2016, at the river sampling sites in approximately three feet of water. An additional gauge was installed at each site to accommodate both high and low flow conditions. Mississippi River water elevation data for the three monitoring locations above the Upper Saint Anthony Falls Lock and Dam are shown in Figure 48. Elevation data for the three sites below the lock and dam are shown in Figure 49. Time periods with missing data were the result of either high river water levels (the staff gauges were submerged underwater or pulled out by the current) or low river water levels (water was below the lowest elevation of the staff gauge). Other gaps may be due to less frequent site visits to read a gauge compared with other gauge sites. Water elevation data were not recorded at site MR853.5E because of the site's close proximity to Saint Anthony Falls and deep water. The staff gauges were removed on November 28, 2016.

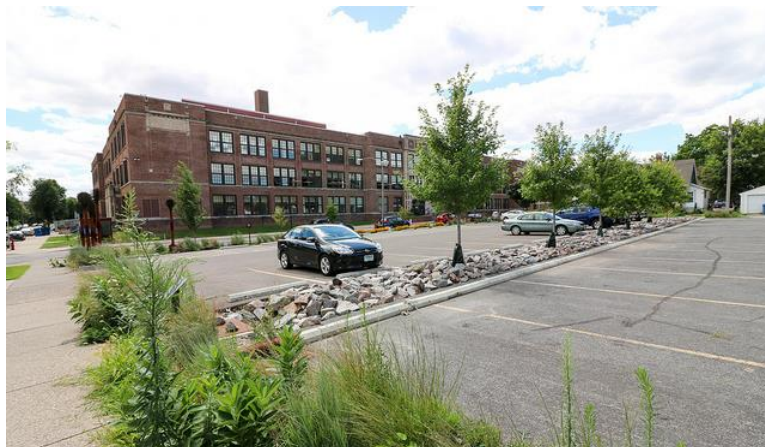
Figure 54. Edison High School parking lot tree trench.
