Kasota Ponds Wetlands: Summary of MWWMO Monitoring Activities 2008–2017

Mississippi Watershed Management Organization. 2019. *Kasota Ponds Wetlands: Summary of MWWMO Monitoring Activities 2008–2017*. MWWMO Watershed Bulletin 2019-4. 53 pp.

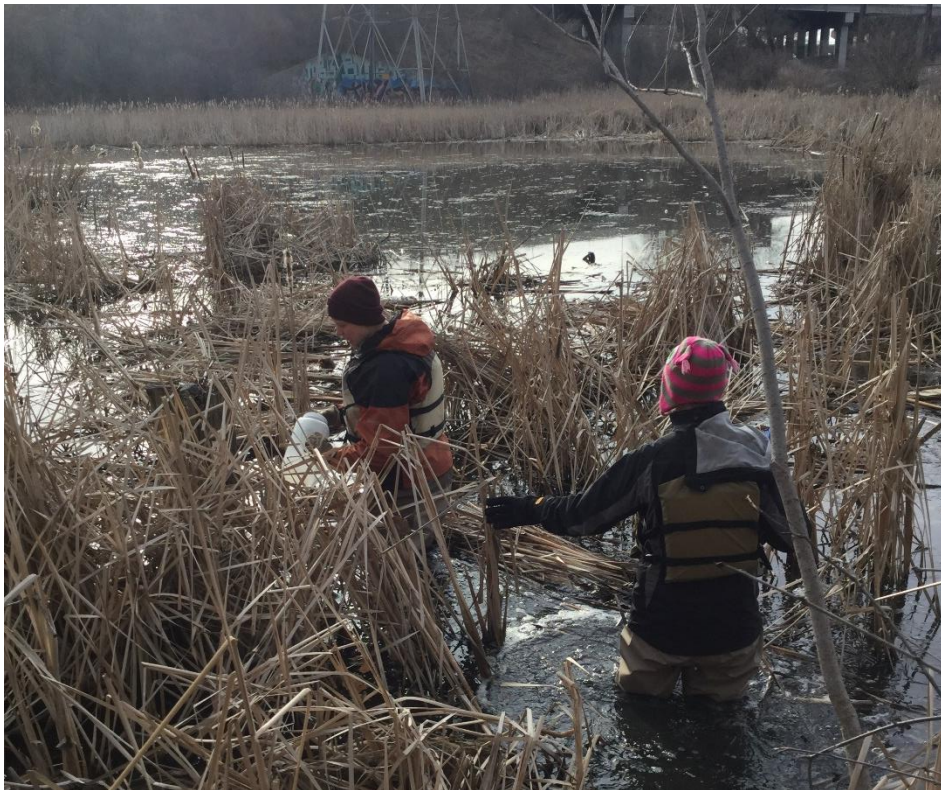
Figure 3. Collecting a water quality grab sample from Kasota Pond North.

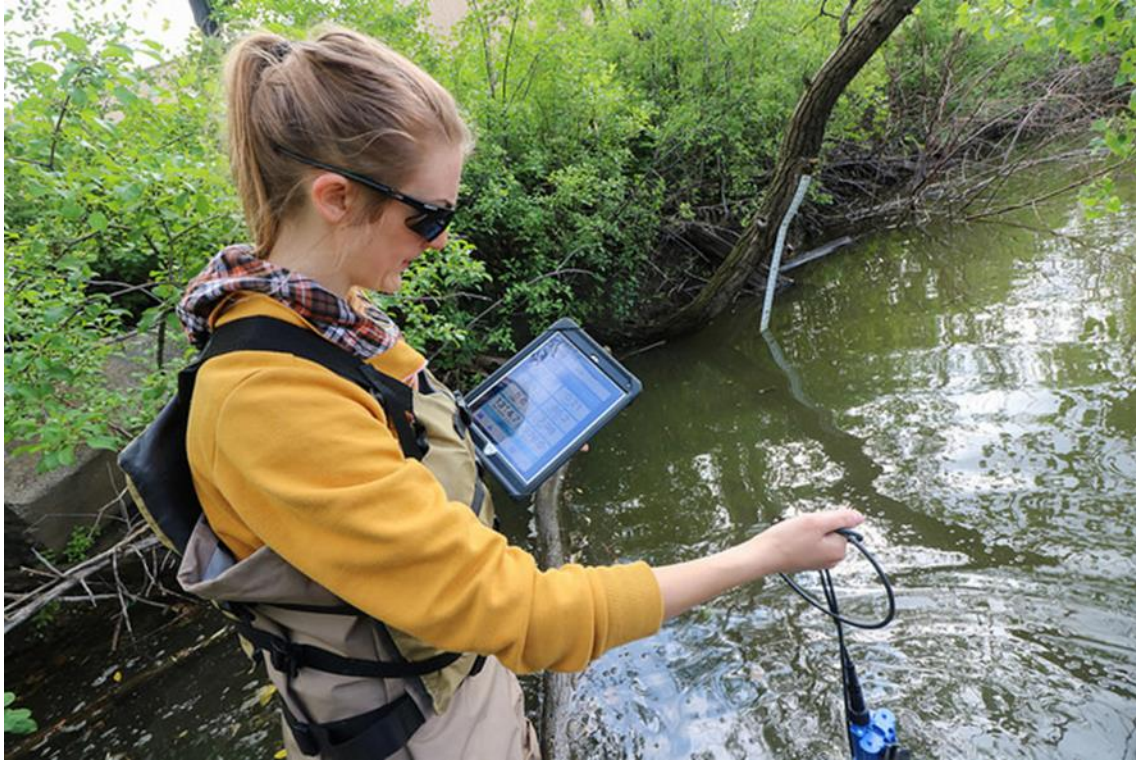
Figure 6. Taking measurements using a handheld multimeter sonde.

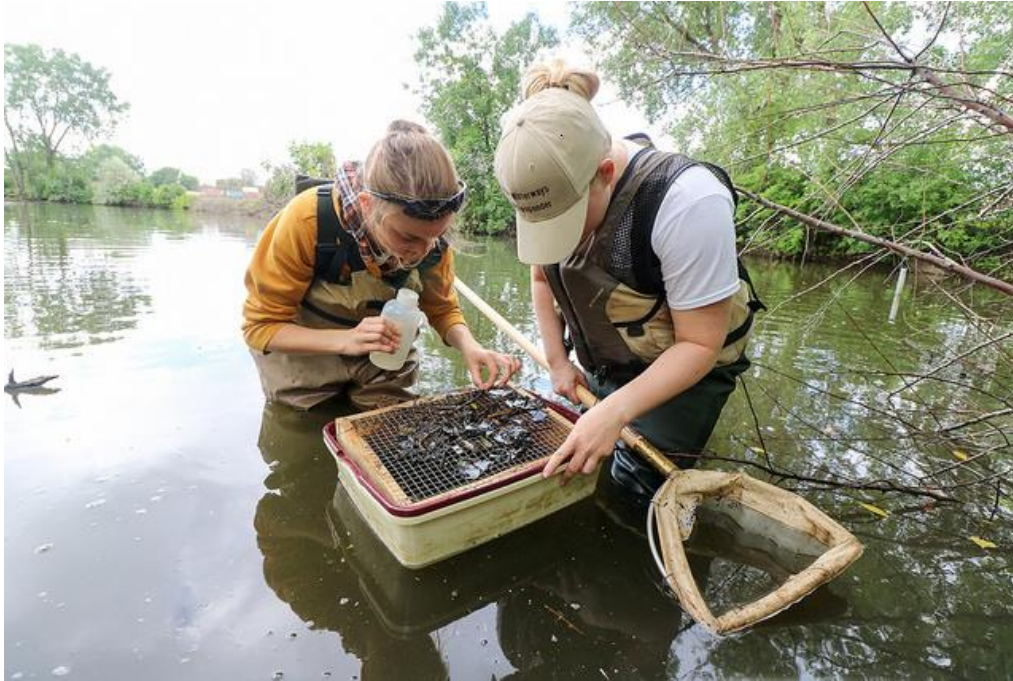
Figure 7. MWMO staff performing macroinvertebrate sampling.

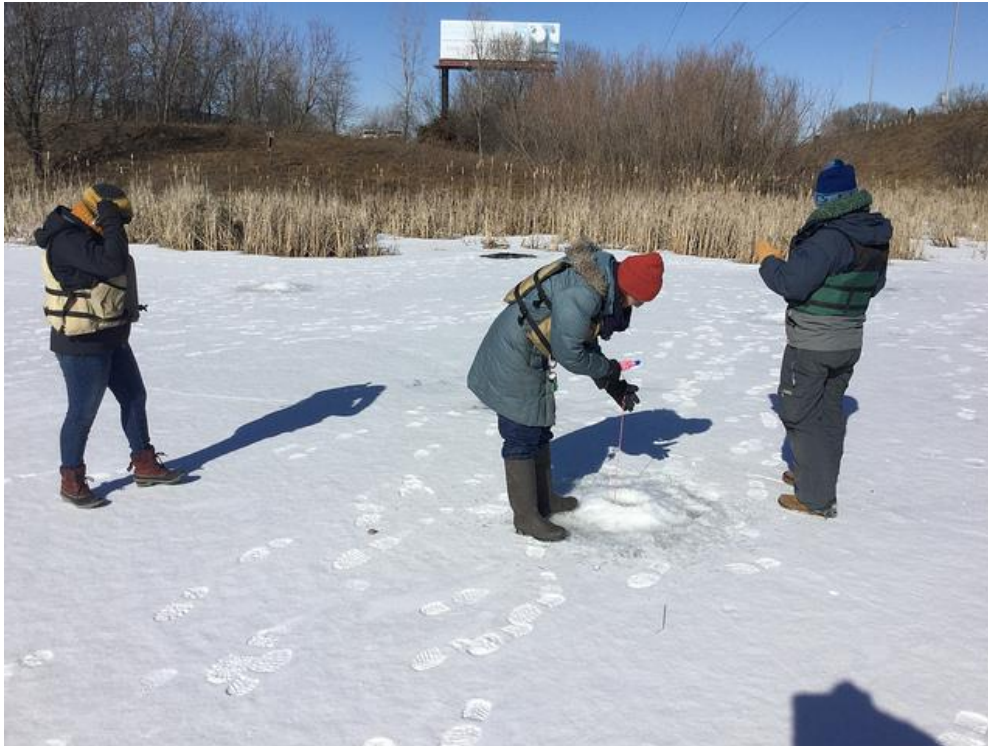
Figure 8. MWMO staff measure depth at drilled holes in pond.

In February 2017, MWMO staff collected water depth data from each of the Kasota Ponds with the goal of creating bathymetric maps and determining the water storage capacity of the wetlands. The current plan is to continue to collect this data every three to five years in order to be able to observe the rate at which the ponds may be filling with sediment.

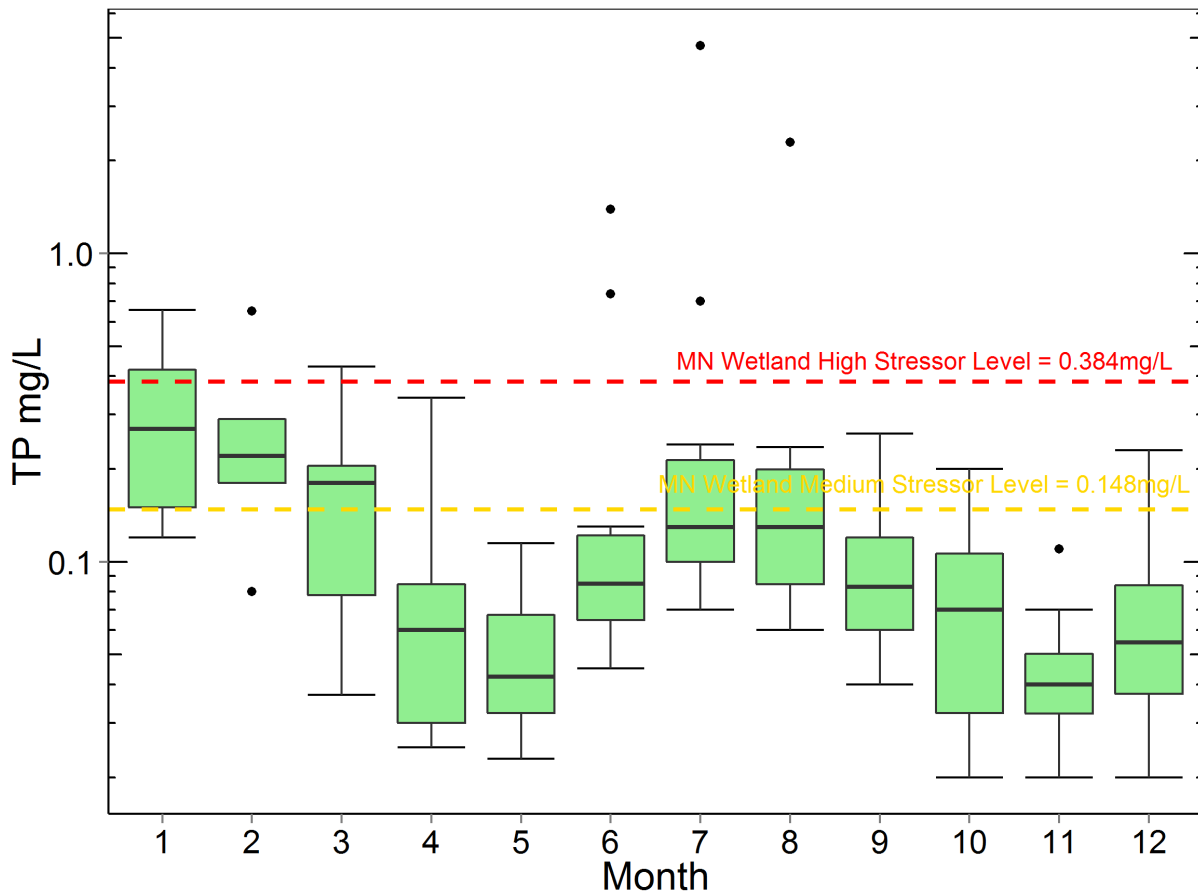
Figure 11. Median monthly total phosphorus concentrations in Kasota Pond North based on data collected between 2008 and 2017. Wetland stressor level categories are represented as lines. Y axis is shown in log scale for visualization purposes. For an explanation of boxplots, see Appendix B.

Total phosphorus (TP) concentration is a concern in freshwater bodies because it is often positively correlated with algae growth and negatively correlated with water transparency/clarity. In other words, as TP concentrations increase, algae levels tend to go up and water clarity subsequently decreases. High algae levels can decrease the dissolved oxygen available for wetland biota. As shown in Table 5, the annual median TP concentration in KPN rarely exceeded the medium stressor level value and did not exceed the high stressor level. However, TP concentrations often vary on a seasonal basis. Figure 11 shows that median monthly TP concentrations at KPN were highest in the winter and summer months. During those seasons, concentrations did occasionally move into the medium and sometimes high stressor categories. Due to its association with sediment particles, TP concentrations may increase in winter and early spring as a result of the higher sediment runoff with melt events. Summer TP increases are likely associated with increased plant biomass in runoff during the peak growing season.

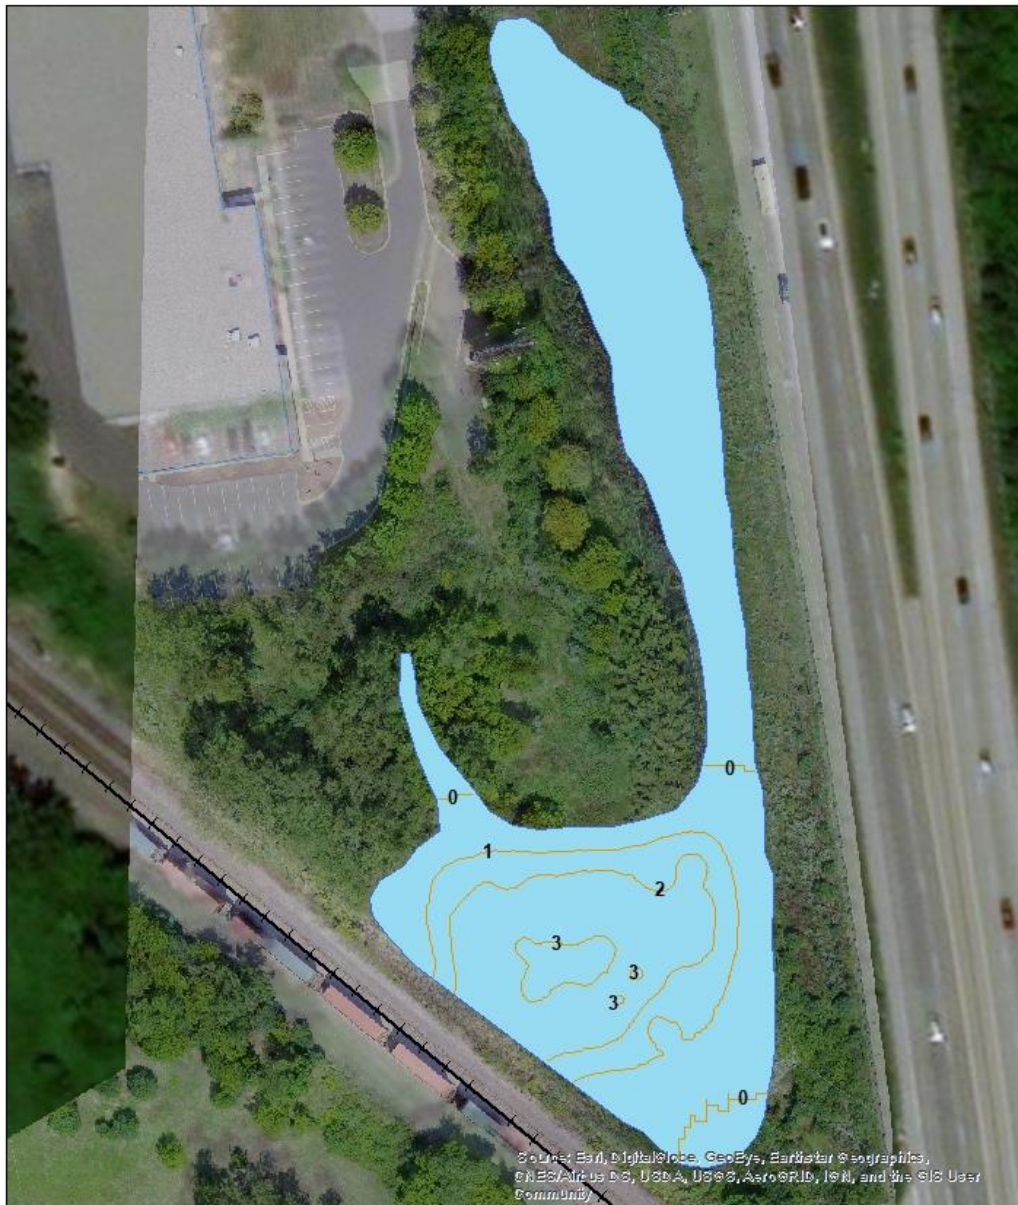
Figure 12. Kasota Pond North bathymetric map.

Pond	Maximum (ft)	Minimum (ft)	Average (ft)
Kasota Pond North	3.2	0.3	2.4

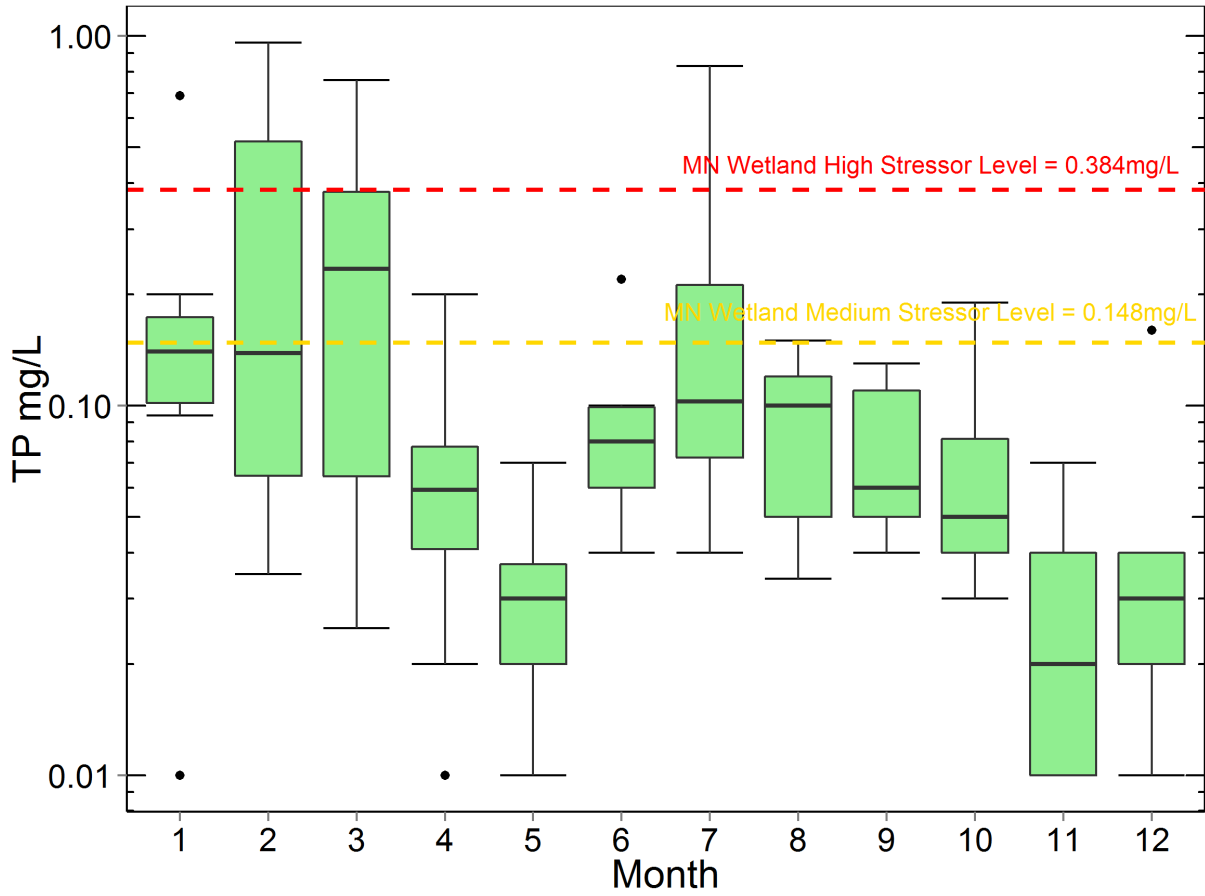
Figure 15. Boxplot of median monthly TP values at KPE for data from 2008-2017 with wetland stressor level categories as lines. Y axis is shown in log scale for visualization purposes.

As shown in Table 9, the annual median TP concentration in KPE remained within the low stressor level. However, TP concentrations often vary on a seasonal basis. Figure 15 shows that median monthly TP concentrations at KPE were highest in the winter/early spring and increased again during summer months. The March median TP concentration rose into the medium stressor level category, while all other monthly medians remained in the low stressor category. Due to its association with sediment particles, TP concentrations may increase in winter and early spring as a result of the higher sediment runoff with melt events. Summer TP increases are likely associated with increased plant biomass in runoff during the peak growing season.

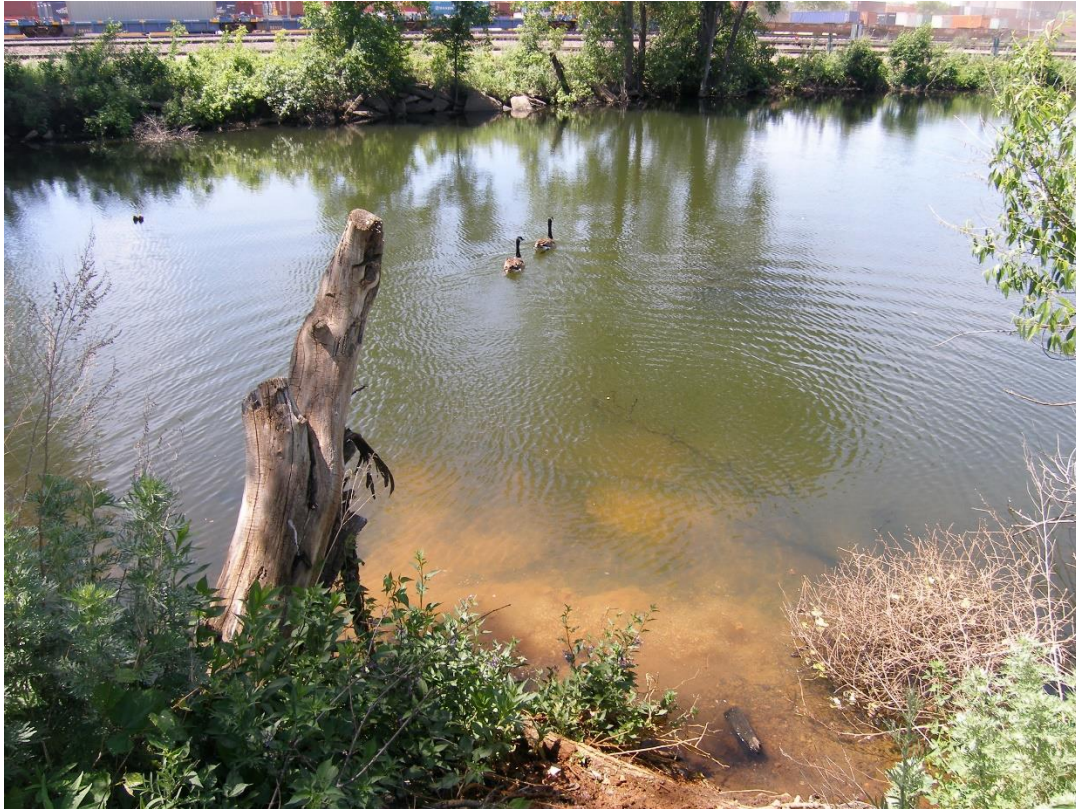
Figure 17. Canada geese in Kasota Pond West.

Kasota Pond West is the smallest of the Kasota Ponds and located just west of Kasota Pond East (Figure 1). KPW receives runoff from a nearby parking lot and railyard. In the summer months, it is often host to dense algal blooms while other aquatic vegetation is seldom present. The pond has a sandy bottom with a few inlet pipes feeding into it. From 2008-2011, the MWMO sampled two sites within KPW on the north and east sides (Figure 4). From 2012-2017, samples were only taken at the north location (Figure 18).

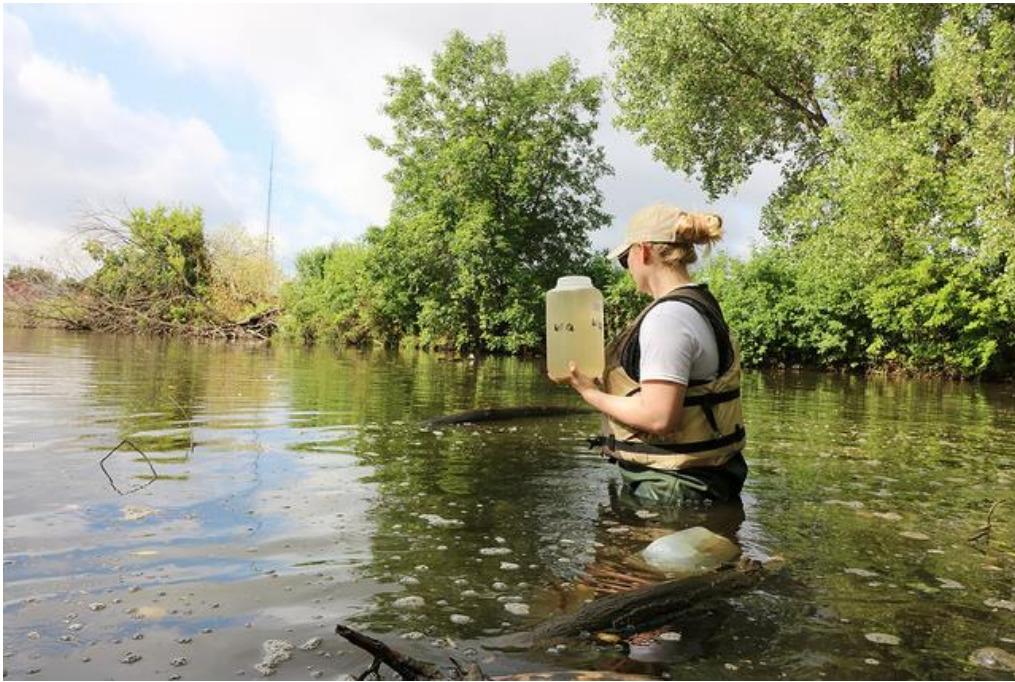
Figure 18. MWMO staff collects water quality sample in Kasota Pond West.

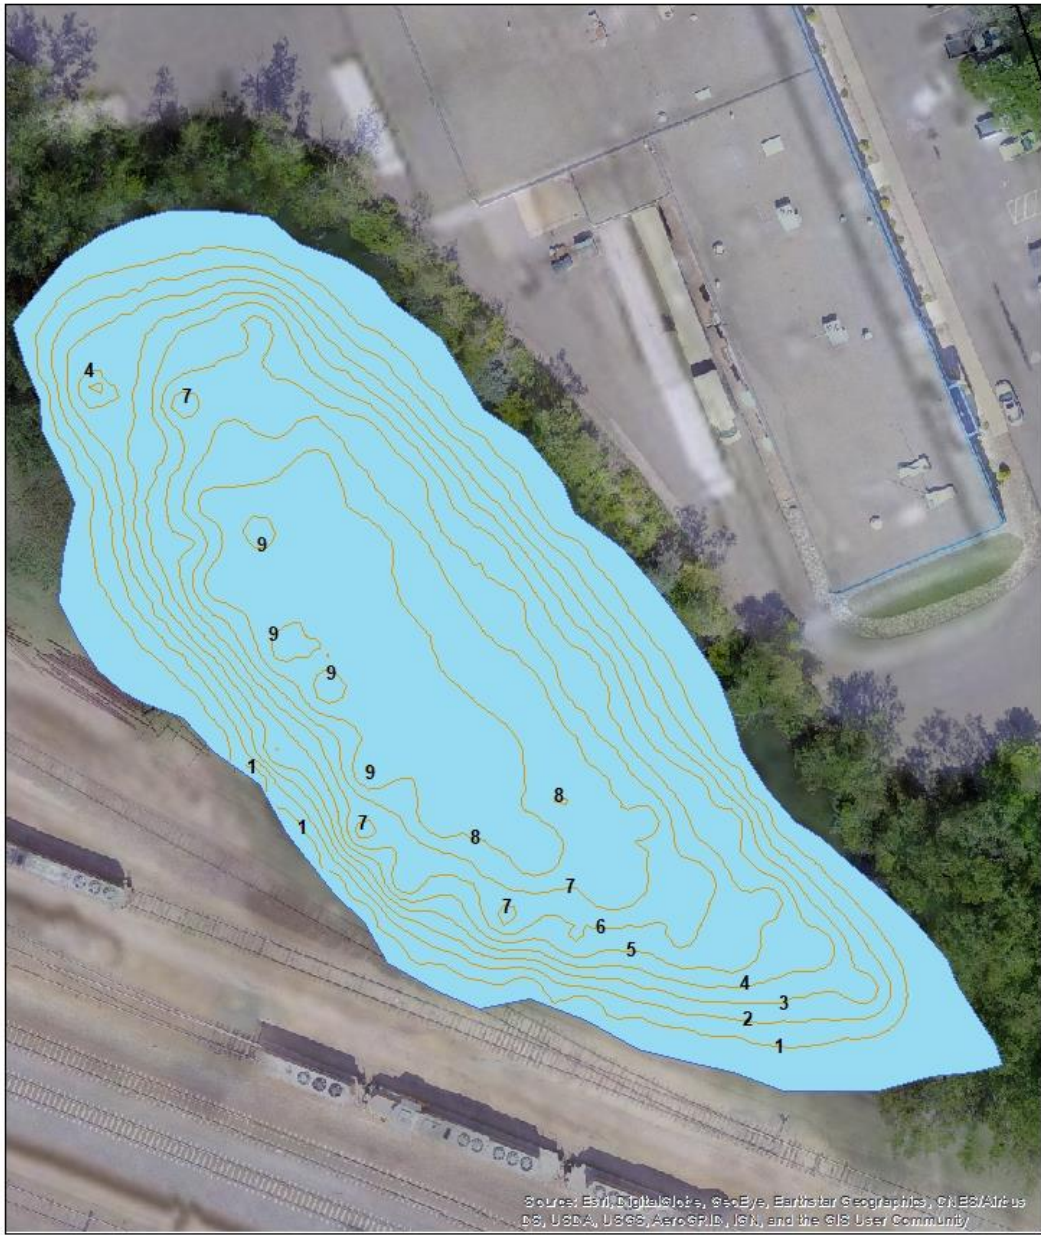
Figure 21. Kasota Pond West bathymetry map with one-foot contours.

Pond	Maximum (ft)	Minimum (ft)	Average (ft)
Kasota Pond West	9.5	3.1	6.8

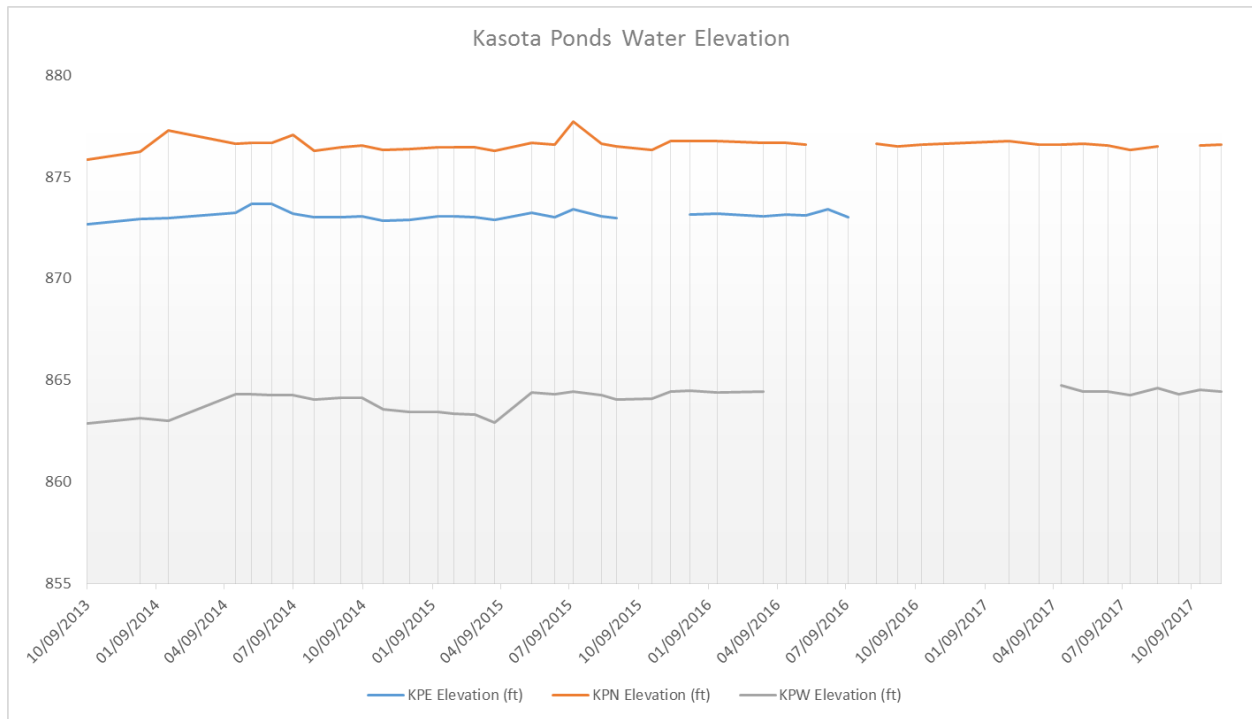
Figure C.1. Recorded water elevation of the Kasota Ponds from 2013 to 2017.

Using depth measurements from the bathymetry study, recorded staff gauge readings, and known elevation markers in the area, MWMO staff were able to calculate the elevation of the ponds. The elevation data show that the northernmost pond (KPN) is at the highest elevation, followed by the eastern pond (KPE) and then the western pond (KPW) (Table C.1 and Figure C.1).
